ULTRASONOGRAPHIC EVALUATION OF NORMAL SCAPULA IN THE HORSE

M. S. AHRARI-KHAFI, A. TABATABAEI NAEINI & N. AJVADI

Ahrari-Khafi, M. S., A. Tabatabaei Naeini & N. Ajvadi, 2018. Ultrasonographic evaluation of normal scapula in the horse. *Bulg. J. Vet. Med.*, **21**, No 1, 50–58.

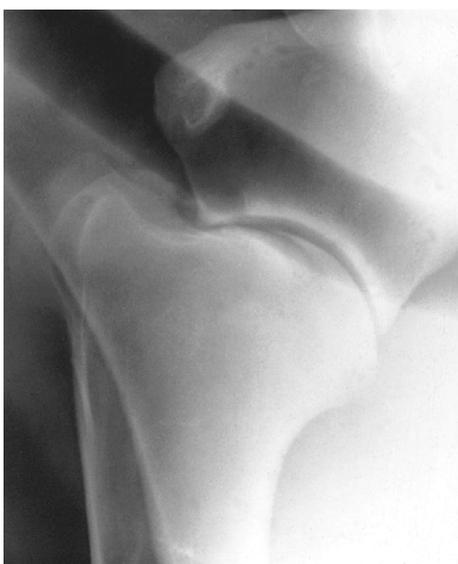
Fig. 1. Mediolateral radiograph of the equine shoulder joint. Due to the superimposition of the thorax and contralateral scapula only small part of the scapula in distal region can be depicted by radiography.

distal parts of scapula such as glenoid cavity and acromion process (Fig. 1). Due to the superimposition of the thorax and contralateral scapula, fractures in upper regions are difficult to identify on radiographs (Davidson & Martin, 2004). Although ultrasonography is mainly used for diagnosis of soft tissue injuries, it also can be used for evaluation of bone surface abnormalities (Redding & Pease, 2010). It is more relevant in diagnosis of fractures in areas where there is difficulty in radiographic imaging, such as pelvis and scapula in large animals. The normal ultrasonographic appearance of equine shoulder region has been described (Tnibar *et al.*, 1999; Kidd *et al.*, 2014), however, according to our best knowledge there is no detailed description on normal ultrasonographic anatomy of the scapula in horse.

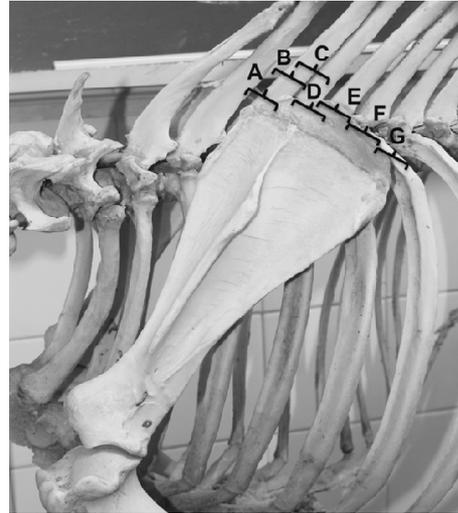
Fig. 2. Scapular bone craniocaudally is divided to 7 zones (A–G) in longitudinal plane.

zones were established from cranial to caudal border of the scapula, namely zone A: cranial border of the scapula to supraspinatus fossa; zone B: supraspinatus fossa; zone C: supraspinatus fossa and having scapular spine on the edge of image; zone D: scapular spine; zone E: infraspinatus fossa and having scapular spine on the edge; zone F: infraspinatus fossa with small overlap with zone E; zone G: infraspinatus fossa to caudal border of the scapula (Fig. 2). By placing the ultrasound probe transversely in the dorsal border of the scapula on each longitudinal zone and sliding ventrally, transverse images were taken from dorsal border to the shoulder joint. In zone D the scapular spine in the mid portion has an orthogonal position to the scapular surface or sometimes is bowed caudally, so both sides or caudal side of the scapular spine cannot be depicted easily so probe fanned caudally or cranially to evaluate cranial or caudal sides of the scapular spine respectively. If the scapular spine be bowed enough, may be its caudal side cannot be seen at all. Going ventrally the width of the scapula progressively decreases, so adjacent zones gradually were overlapped. In transverse axis 10 (1 to 10) zones were also established. Due to the limited width of our ultrasound probe that was about 4.5 cm, every 4 cm length of the scapula considered a transverse zone, starting in dorsal border and continuing to the shoulder joint (Fig. 3). The number of zones may increase in taller or decrease in shorter horses. By placing the ultrasound probe longitudinally in the cranial border of the scapula on each transverse zone and sliding caudally, longitudinal images were taken from cranial to the caudal border. Longitudinal and transverse plane images of all examined parts were saved and transferred to a PC for more evaluation.

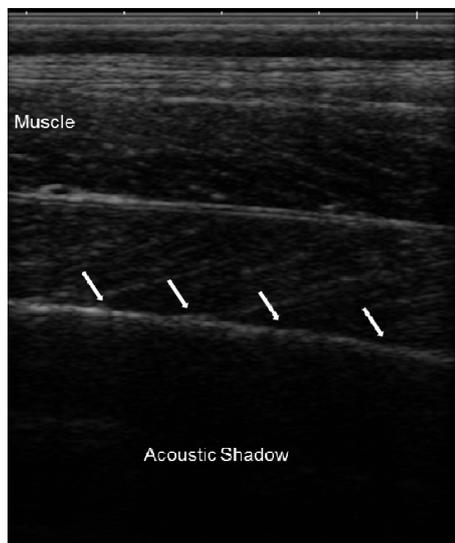
Fig. 4. Surface of the scapula can be seen as a hyperechoic line (arrows) above the acoustic shadow. The image was obtained using a linear array transducer with 8–12 MHz frequency and depth was set at 62 mm.

The surface of the scapula was imaged as linear hyperechoic contour showing acoustic shadowing distally that is characteristic for bone image ultrasonographically (Fig. 4). However mirror-image artifact sometimes prevents the shadowing to be completely clean (Fig. 5). By sliding the probe dorsoventrally and craniocaudally in the defined zones, continuity of the scapular bone could be seen, except about disruption caused by the scapular

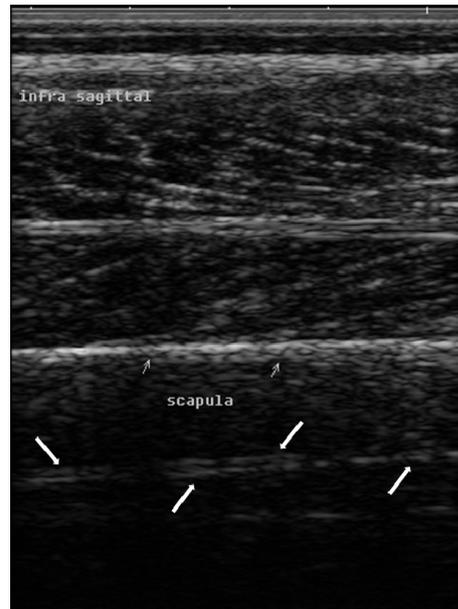
Fig. 5. Below the scapular bone (small arrows) mirror-image artifact can be seen (large arrows). The image was obtained using a linear array transducer with 8–12 MHz frequency and depth was set at 62 mm.

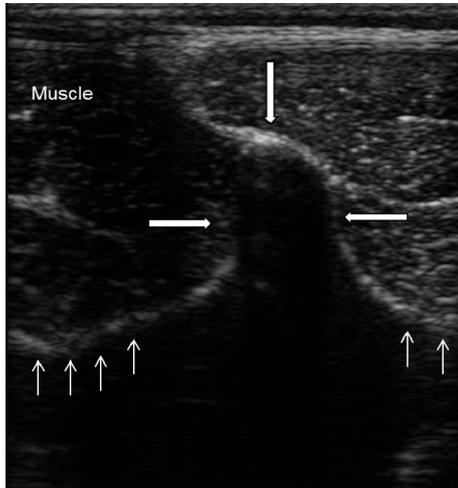
Fig. 6. Transverse image in zones D and 5, showing scapular spine (large arrows) as a disruption in the straight bone surface (thin arrows). Cranial is to the left. The image was obtained using a linear array transducer with 8–12 MHz frequency and depth was set at 62 mm.

spine in longitudinal images when passing zone D and in transverse images of zone D (Fig. 6).

of the acoustic shadowing was the cranial border and caudally just before termination of the shadowing was the caudal border. In longitudinal zones cranial and caudal borders could be recognised in zones A and G respectively just next to acoustic shadowing caused by scapular bone (Fig. 8). Dorsoventrally the width of the transverse zones decreased gradually. In zone D the scapular spine initially appeared as a convex surface dorsally, gradually increased in height to the middle of the scapula and thereafter its height decreased gradually (Fig. 6, 9).

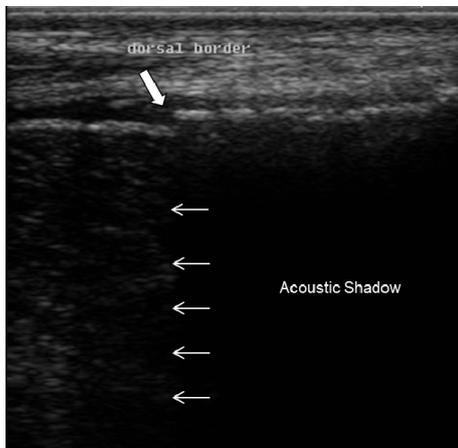
Fig. 7. Longitudinal image in the dorsal border of the scapula (large arrow). Above the dorsal border that is scapular cartilage, ultrasound waves could pass to the soft tissues (thin arrows). Dorsal is to the left. The image was obtained using a linear array transducer with 8–12 MHz frequency and depth was set at 62 mm.

The dorsal border of the scapula was seen in longitudinal plane in zone 1 by sliding the probe craniocaudally from zone A to zone G. Just above the dorsal border, ultrasound waves could pass to the soft tissues and acoustic shadowing caused by scapular bone that could serve as a guideline for locating edge of the dorsal border no longer exists (Fig. 7). By placing the probe in longitudinal plane and sliding craniocaudally in the next transverse zones (2–10) the continuity of the bone surface could be evaluated. In transverse zones cranial and caudal borders could be recognised by sliding of the probe craniocaudally; cranially beginning

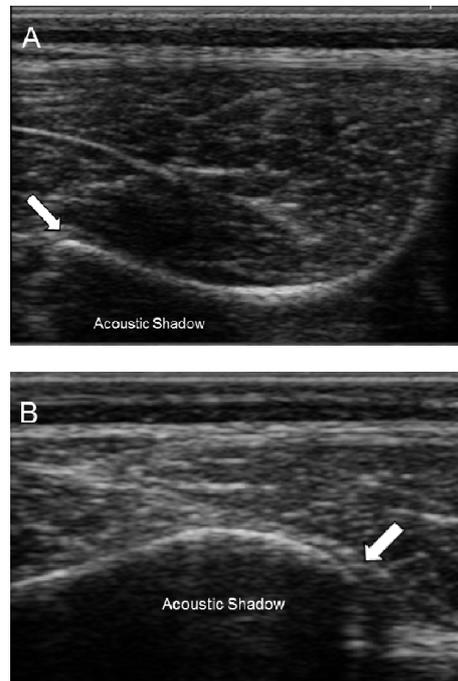
Fig. 8. Cranial (A) and caudal (B) borders of the scapula in transverse images are shown in zones A and G, respectively. Beginning of the acoustic shadowing indicates borders (arrows). Cranial is to the left. The image was obtained using a linear array transducer with 8–12 MHz frequency and depth was set at 62 mm.

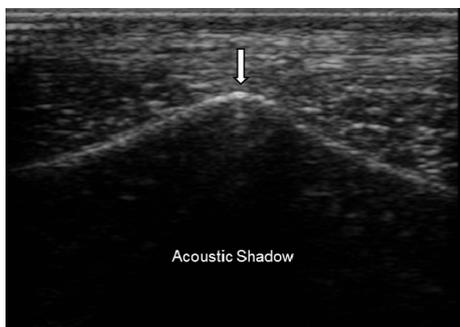
Fig. 9. Transverse image, zones D and 2, showing convexity of the scapula at beginning of the spine development (arrow). The image was obtained using a linear array transducer with 8–12 MHz frequency and depth was set at 62 mm.

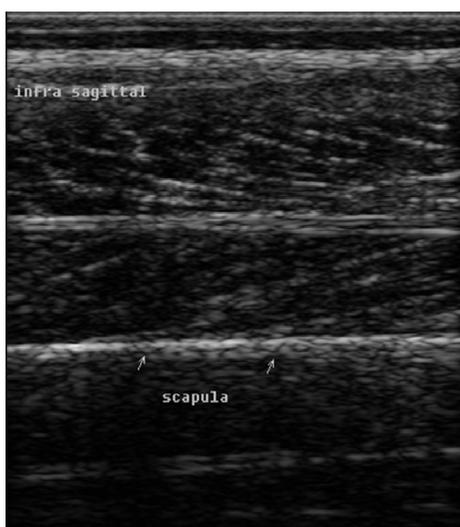
Fig. 10. Infraspinatus muscle is seen between the skin and the scapula (arrows). In longitudinal plane muscle seen relatively hypoechoic with fine, oblique, hyperechoic striations. Dorsal is to the left. The image was obtained using a linear array transducer with 8–12 MHz frequency and depth was set at 62 mm.

cle seen in the supraspinatus fossa and caudally, the infraspinatus muscle seen in the infraspinatus fossa and covered with the deltoideus muscle. The muscles are thickest in the middle of the scapula and the thickness tapers dorsally and ventrally. In longitudinal planes the fibres of the muscles seen as slabs of irregularly striated hypoechoic tissue contained within the thin hyperechoic lines of fascia (Fig. 10). In transverse planes muscles appeared dotted and punctuate, or formed short lines (Fig. 11).

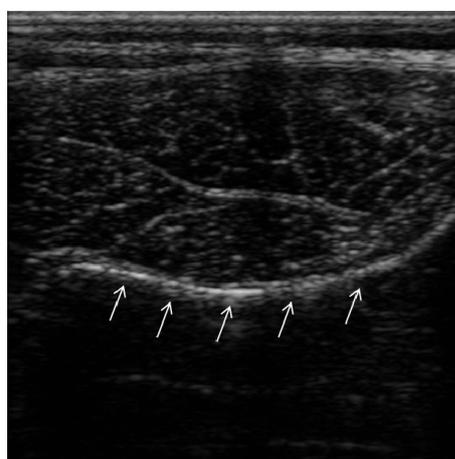
Fig. 11. Supraspinatus muscle is seen in transverse plane above the scapula (arrows). The muscle fibres are seen dotted and punctuate and form short lines. The image was obtained using a linear array transducer with 8–12 MHz frequency and depth was set at 62 mm.
